**3201 BOWMAN AVENUE
AUSTIN, TX**

PROPERTY INSPECTION REPORT

Concerning: 3201 BOWMAN AVENUE, AUSTIN, TX

08/12/2014

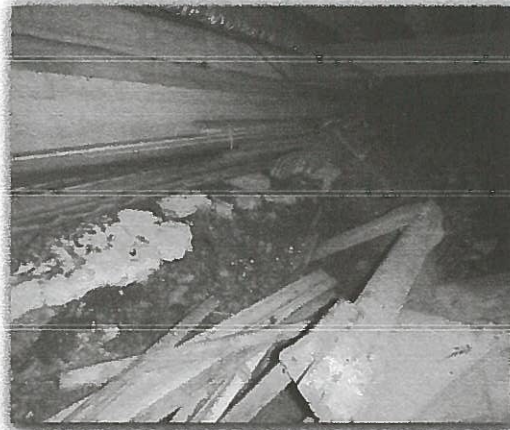
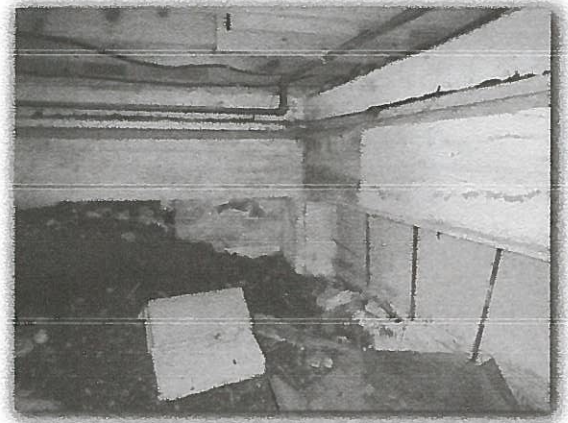
The Home has a Concrete Beam supporting the Perimeter Walls with Formed Pier Footings into Grade (photos below).

Despite some typical hairline cracking running horizontally through the Beams as a result of differential tensions, they appear to be viable and providing good support at these walls. No significant cracking observed in exterior brick.

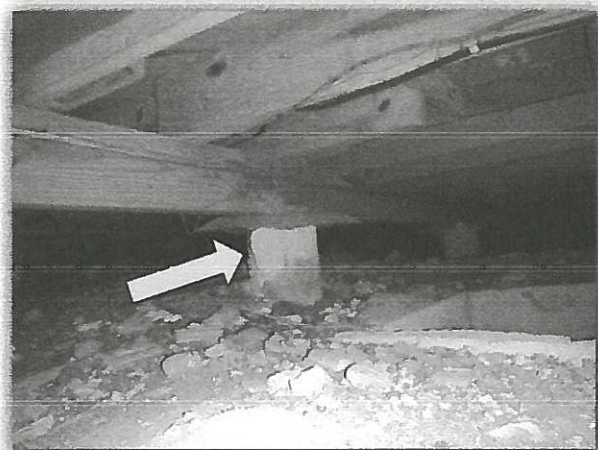
- **One or two of these Piers have some cracking in them (photo below). Repairs to these Piers can be made, or additional Piers placed alongside them.**

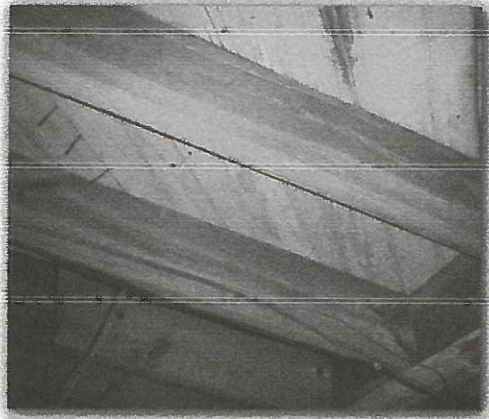
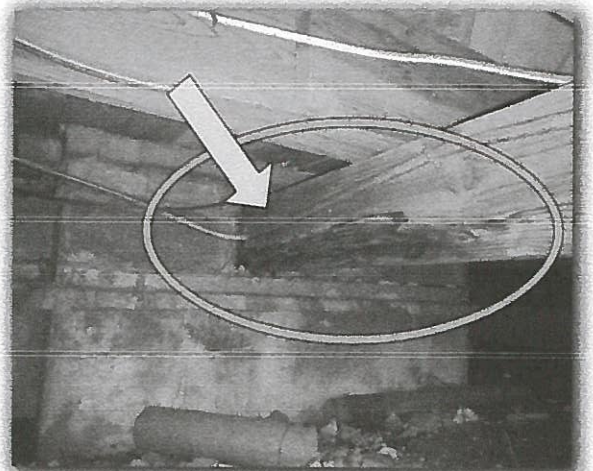
The overall Condition of the Joists and Subflooring (left photo) is good.

- **The Header at the Fireplace Hearth** is decay damaged (right photo) as a result of prior Roof leaks at the Chimney.
- **This Header can be repaired** by sistering new Treated boards of same dimension to both sides of the damaged Header and lag-screwing them together through the original Header.
- The Sistered Boards to extend from the Hearth to the next Pier along the Header.
- A new supporting Pier can then be installed at the Hearth end of the repaired header.
- **Similar Decay Damage** to the Header further along the front wall to the east of the Fireplace (photo below)

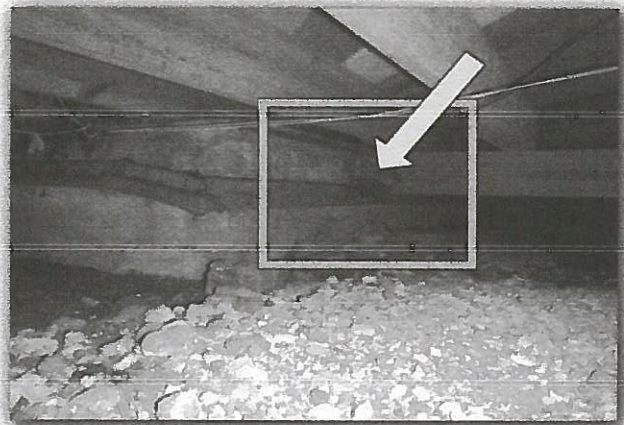
- **Similar Repair** needed to this Header.
- **The Interior Floor does slope noticeably** in the Kitchen, Rear Bedroom areas (photo)

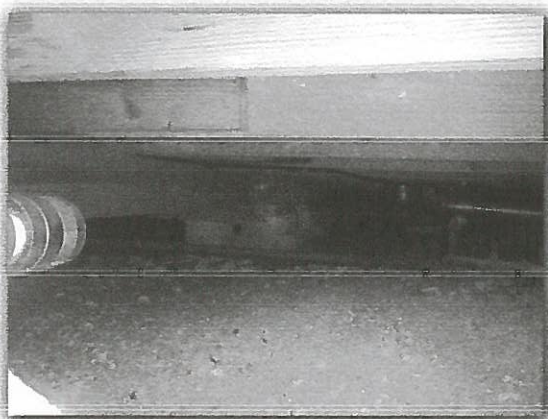
Note: A newer **Treated Lumber Header** (photo above) has been installed in the center of the Crawlspace below the Living Room.

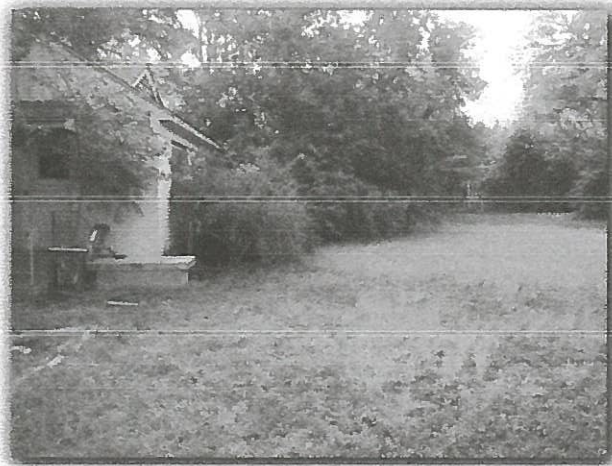
- **Back Yard slopes toward Home.** Construction Plans for a new Home should take this into account and include Landscaping and Drainage improvements to create Positive Drainage and Sloping away from all exterior walls.

- **The existing Retaining Wall** at the rear and east side of the Home is broken as a result of tree growth and soil expansion/contraction.

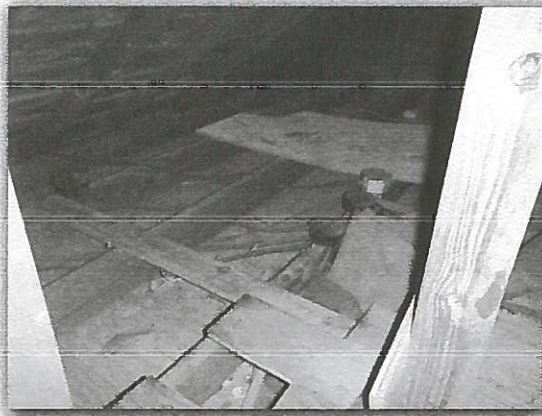
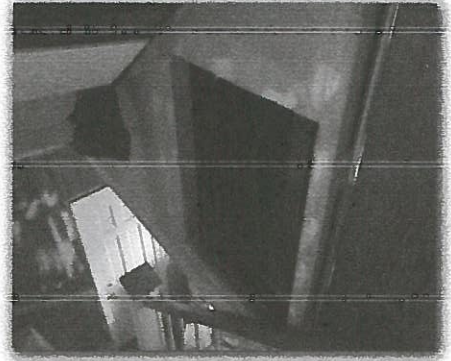
- **Ceilings lack Insulation.** (As do Exterior Walls in all likelihood).

- **Attic Areas (If Remodeling)** need to be Insulated at Ceilings, and Living Walls.

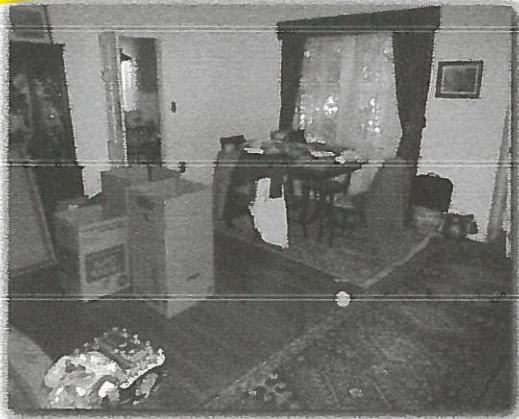
- **The Interior of the Home is crowded with personal belongings and storage.**

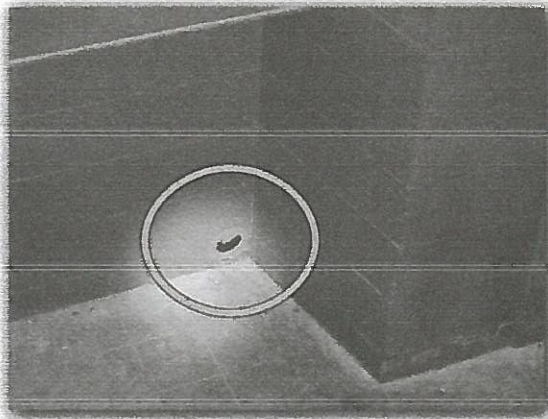
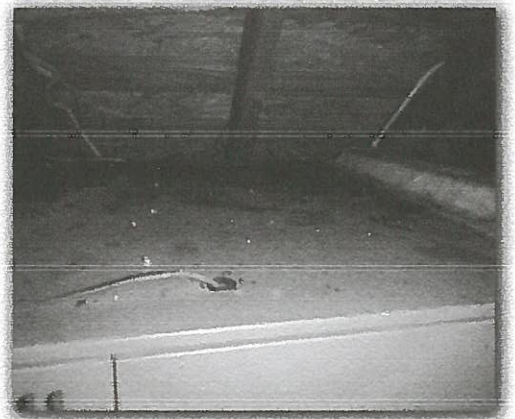
- **When empty one should expect** to find additional defects and repairs that could not be observed under the current conditions.
- **Rodent Infestation** evident at interior walls (left photo) and Attic, urine staining on top of Air Handler, (right photo).

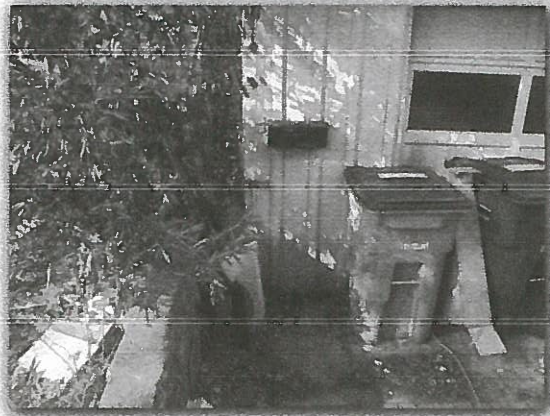
- **The Garage is a Wood-Frame Structure** on a thin Slab Floor at the west end of the Home.

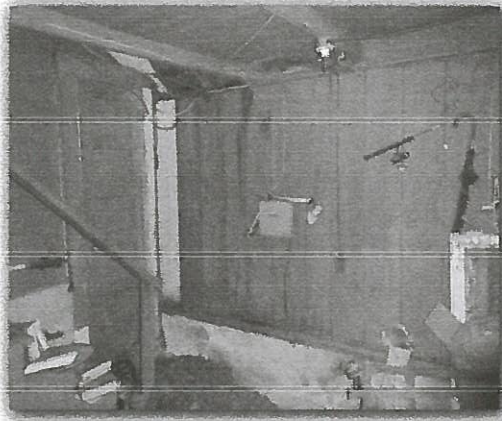
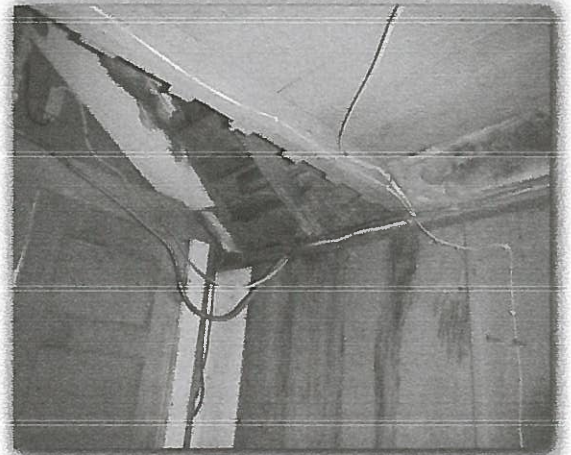
- **The Garage Floor being at same elevation** as exterior Grade leaves the bottom of the Wood walls vulnerable to decay damage and pest activity.
- **The exterior walls are without Studs.** Vertical Plank Siding between top and bottom plates makes up the bearing walls for roof support.

- **The Photos above illustrate this.** Note the original Skip-Sheathing for the original Cedar Shingle (or metal) roofing has been layered with solid Plywood Decking for the current Asphalt Shingle Roofing.
- **A more recently installed Header** on Columns adds supporting stiffness to the Attic Floor.

- The structure of the Garage is poor and decay/pest damage has further weakened it.
- The Slab floor here needs to be repaired or replaced.
- My recommendation is for a complete rebuild of this part of the Home.

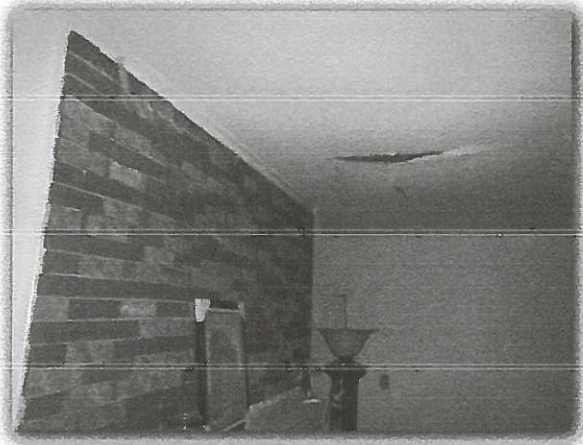
- Lower Level Ceilings damaged by prior Leaks such as at the Living Room at the Fireplace (photo).

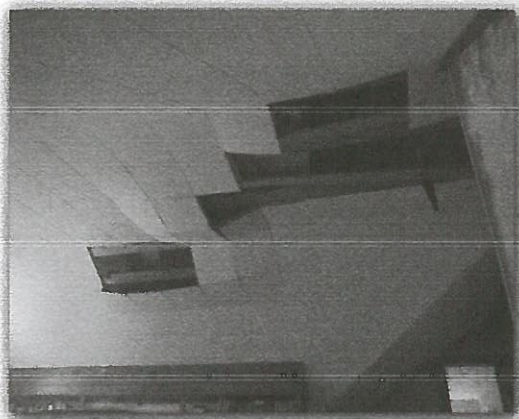
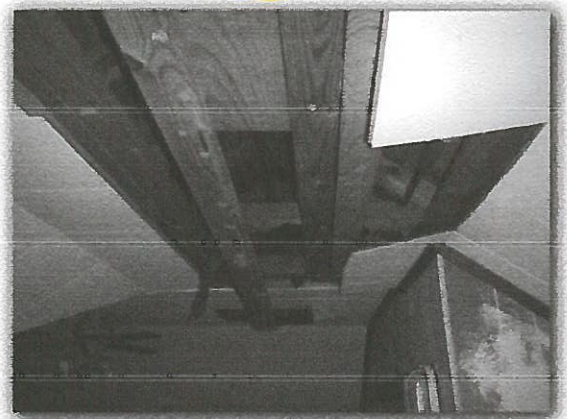
- The Cellulose Ceiling Tile in the 2nd Floor Ceilings is collapsing.

- Gaps In the Tile reveal they are attached to 1 x 4 Skip-Boards on the underside of the Joists. This is poor support for the Tile.
- If the Home is to be remodeled, remove all Cellulose Tile. Remove 1 x 4. Repair Joists to be able to support Drywall.

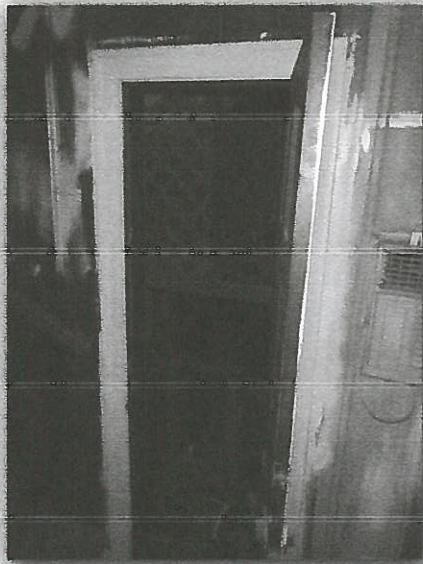
- **Under-sized Garage Entry Door (below left).**

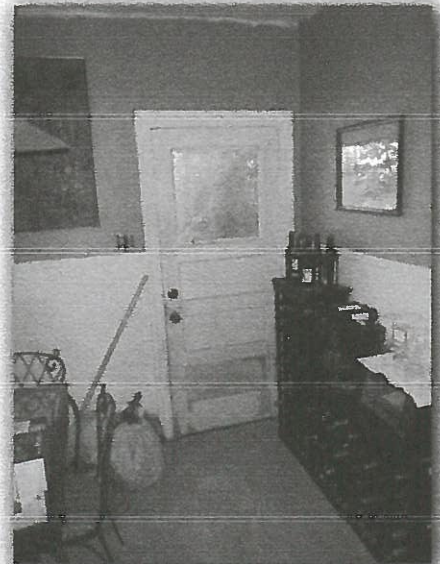
- **Glass in the Back Porch Door (right) is not tempered safety glass.**

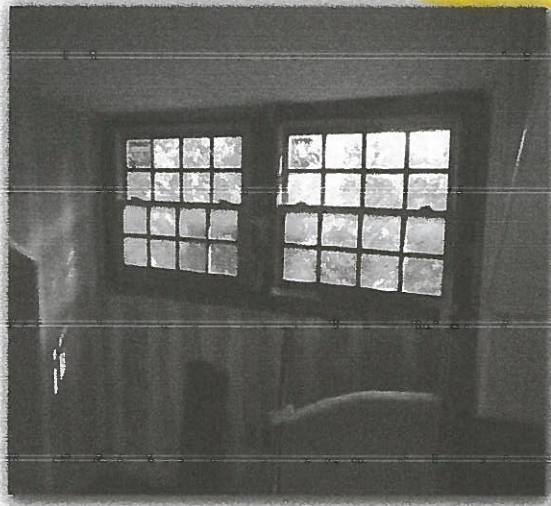
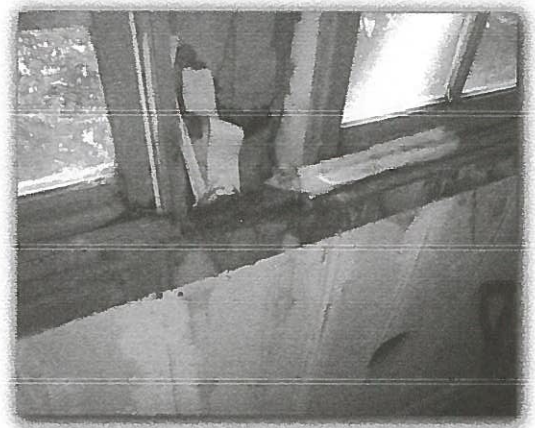
- **The newer Upper Dormer Windows** lack proper Flashing at the Sill. Water damage occurring to wall below windows (right).

- **If Remodeling the Home**, these Windows should be removed to properly Flash the wall opening and the Sill. Then Windows to be re-installed.
- **Note: Upper Bedroom** will need at least one operable Window with an opening large enough to allow emergency rescue and/or escape.

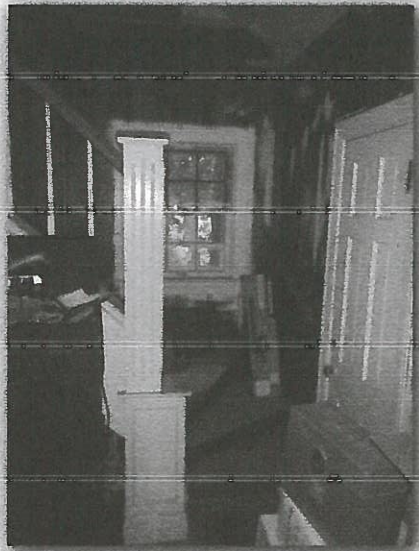
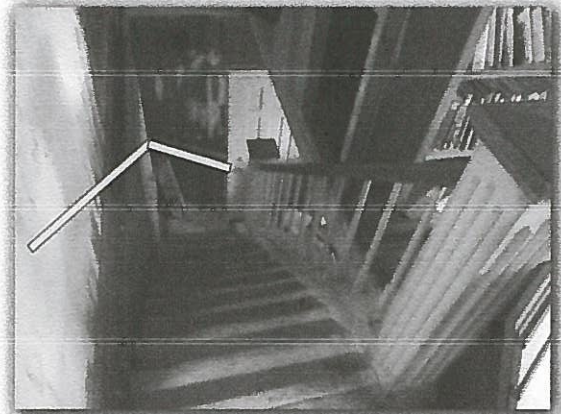
- **Stairway to Loft/2nd Floor** is sub-standard in several ways:
- **Winder Steps** at bottom are too small.
- **In fact Tread depth** at all Steps are too shallow.

- **The Window** in the Stairway should be Tempered Glass.
- **A Continuous Grippable Hand Railing** is needed on the wall from the top of the Stairs to the bottom (right photo).

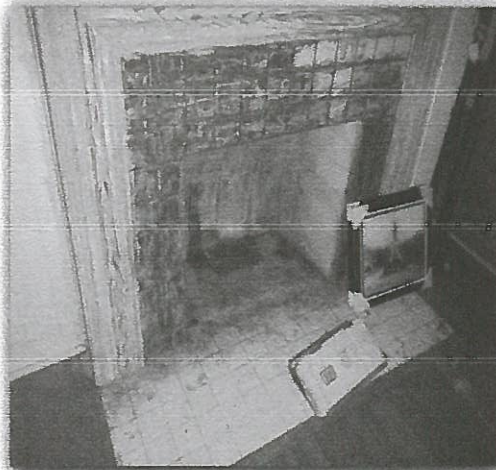
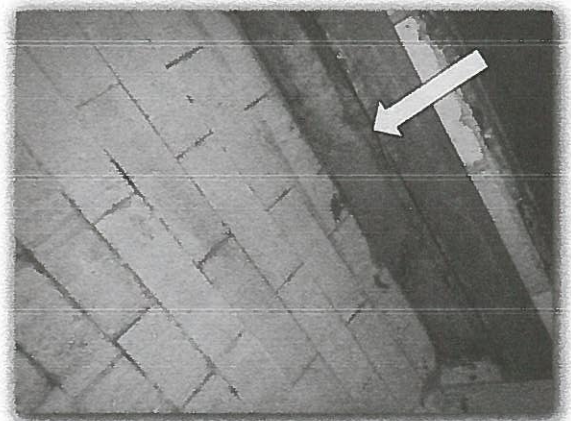
- **The Living Room Fireplace** (below left) has a narrow Flue opening at the Damper (right).

- **If Remodeling, a Chimney Contractor** should repair the Flue
- **Install a Flue-Top Damper** operated by a Pull-Wire Hitch in the Fireplace. This will make the Home more energy-efficient and keep the elements and pests out of the Flue.

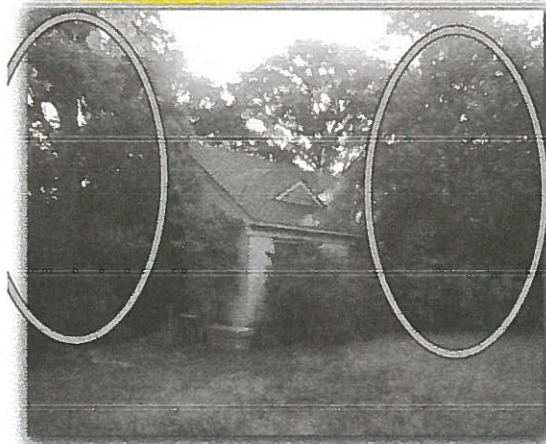
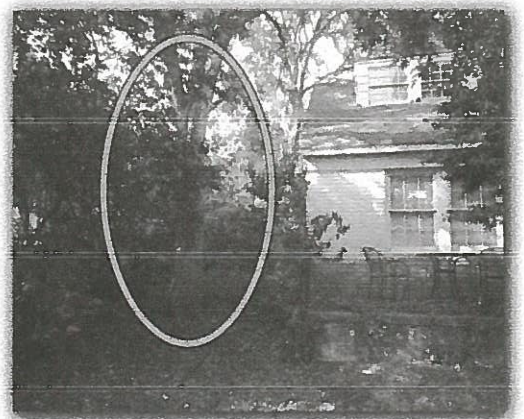
- **Re-Development of the Site** will involve accommodating protected Trees within the requirements of the City Arborist.

- **Elms at the rear walls** (left) walls of existing Home will likely have to stay, as will the Elm at the east end (right).
- **Junked Vehicles** (photo) Containers with Fuels, Oils and other chemicals will need to be

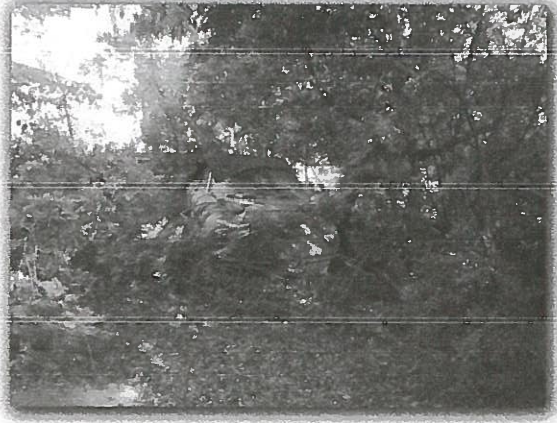
removed from the site.

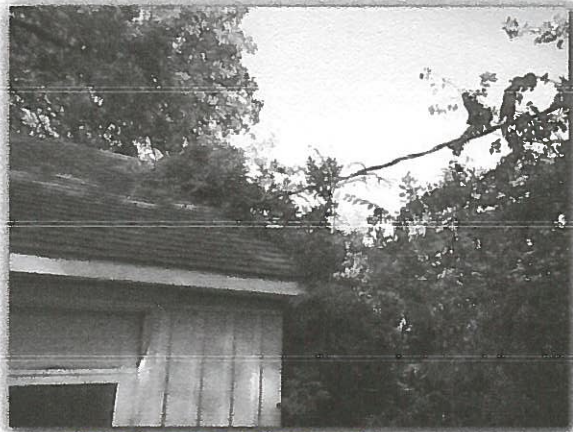
- Existing Electrical Service is to the Garage front right rake eave (photo).

- Rebuild of Garage/Home will involve a new Service Drop to a new Mast at a new Eave.
- Grounding is to a Hose Bibb at the Garage interior wall (left photo).

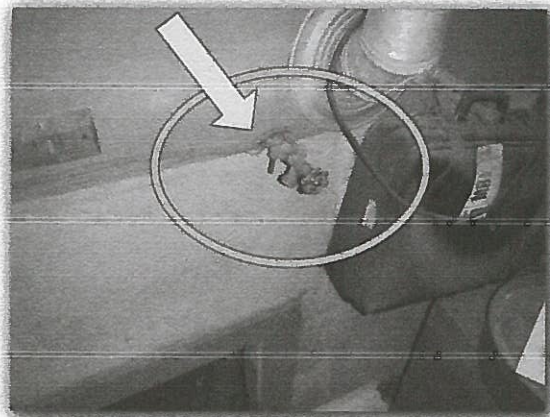
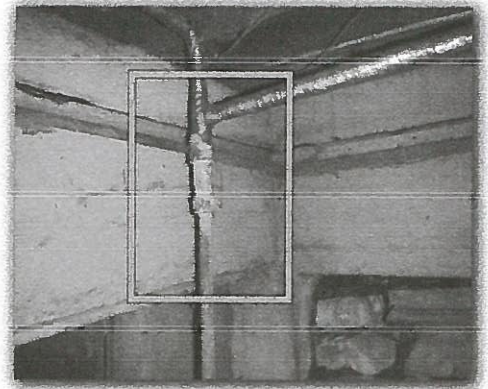
- **This is no longer viable** since a PVC Connector in the Crawlspace bridges the Crawlspace Steel Water Main (right photo) to the Copper Crawlspace Tubing.
- **New Electrical Service** will involve a new Grounding Rod where the new Meter and Main Breaker Box is to be located.
- **All Metallic Water Supply** will then be Bonded back to this new Grounding.
- **Gas Supply Tubing** must also be Bonded back to Grounding.
- **Original Fuse/Switch Boxes** in Garage Wall by Entry Steps to be replaced either at a new Exterior Main Breaker Box, or a new Sub Panel in the rebuilt Garage or Home.

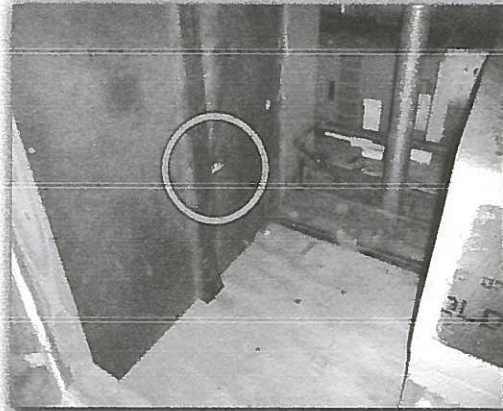
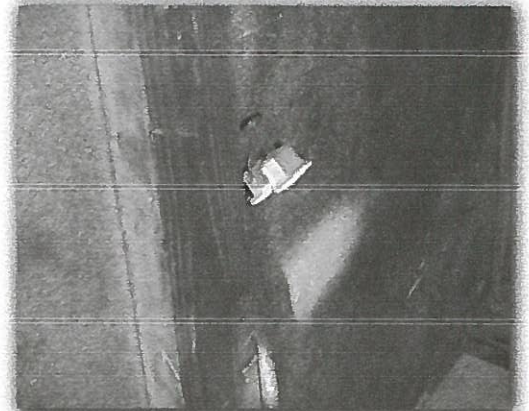
- If Remodeling Power to be turned off in Home. There are several dangerous Outlets in walls (right) where electrocution or fire can occur.

- If Remodeled the Home will need all-new Wiring/Fixtures and Outlets.

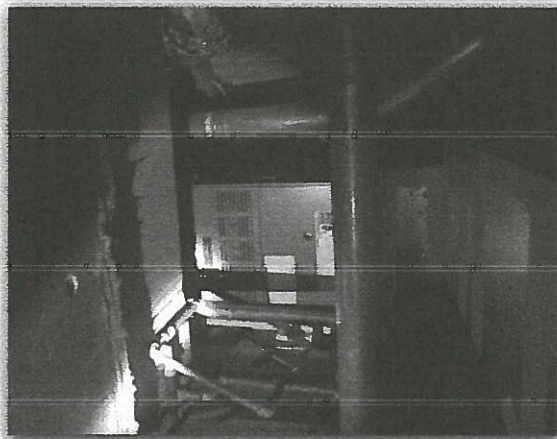
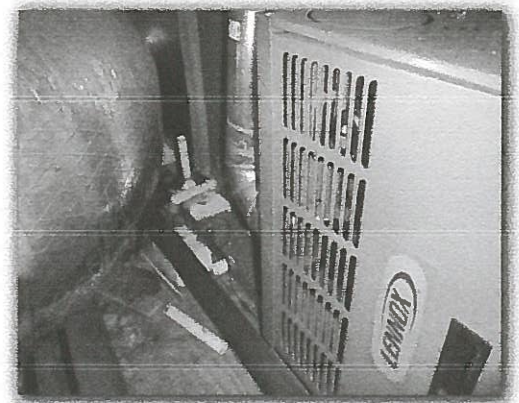
- 2006 model Air Handler is shoe-horned into the limited Attic Space at the rear of the Loft Bedroom.

- If remodeling, open-up this Attic so that the AC equipment is fully accessible. Re-Route all tubing and vents out of the access to the equipment.
- Gas to have a Sediment Tee at the Air Handler, and Hard-Pipe at the entry to the Furnace Cabinet.
- Abandoned Space Heaters still in place in the underside of the Floor at the Crawlspace can be removed

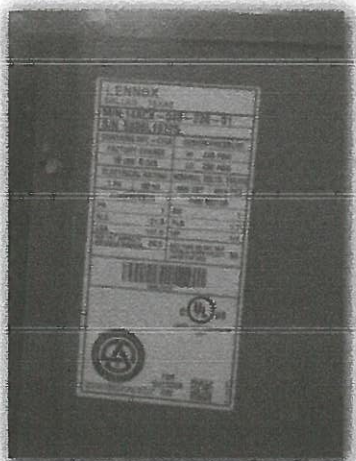
AC Equipment is a Lennox brand, 14 SEER, 2006 model 4 ton 50 amp package with HFC-410A refrigerant

- **If remodeling** service and tune-up the AC.
- **Recommend adding a Safe-T-Switch device** to the Primary Drain Clean-Out at the Attic Air Handler to alert you to flow problems with the Primary Drains before Overflow Pans start to fill.
- **The Window Unit in the Study** wall vents to the Garage!

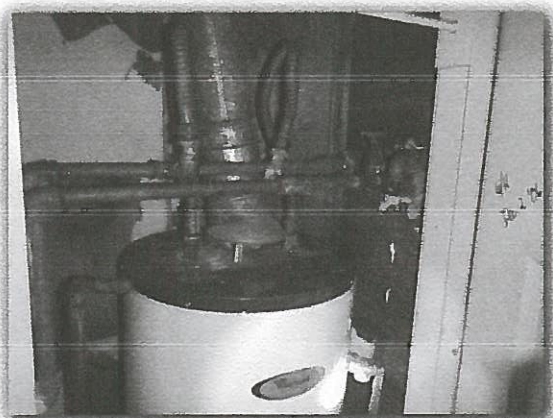
- Household Supply Plumbing is a mix of original Steel Tubing (photo) and more recently installed Copper tubing.

- It all will need to be replaced, including the Water Main from the Meter to the Home (Remodeled or New).

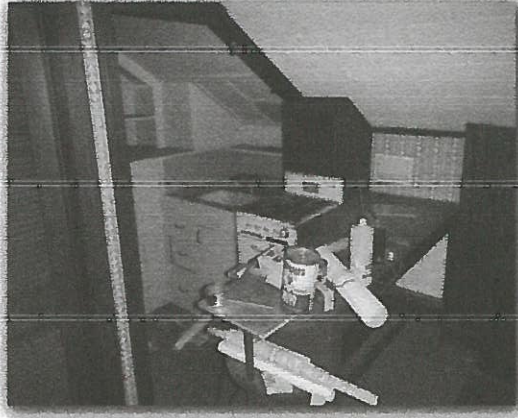
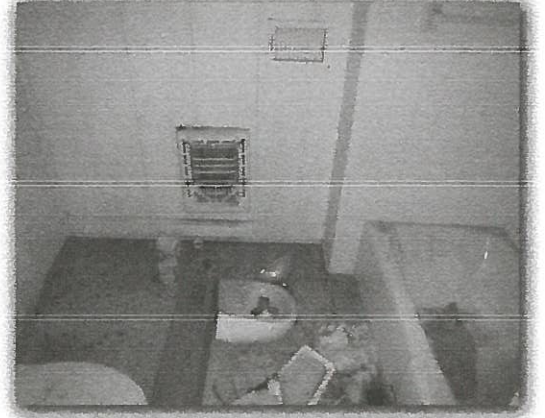
- **Upper Kitchenette and Bath Fixtures** (below) are in broken, dilapidated condition.

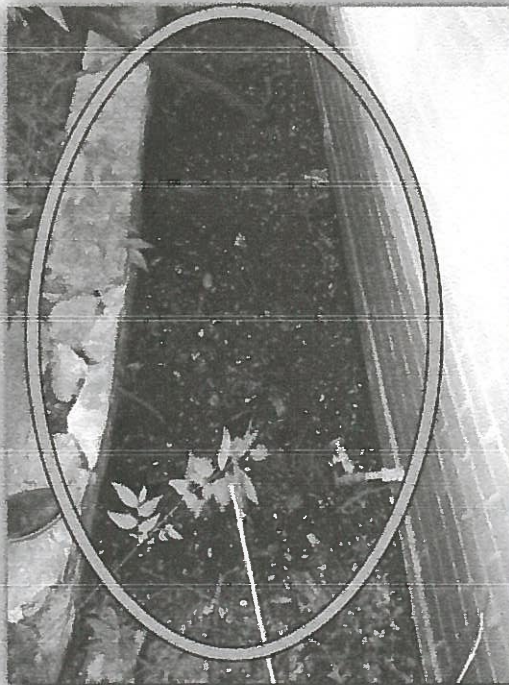
- **Saturated and blackened soil** between the left east side of the Home and the retaining wall (photo) is indicative of broken and leaking Drain Line here from this side of the Home to the Street Tap.

- **A new Drain** is needed from the Home to the Street Tap.
- **New Clean-Outs** needed at the exterior wall here.
- **Crawlspace Drain Plumbing** (if remodeling) will need to be replaced.

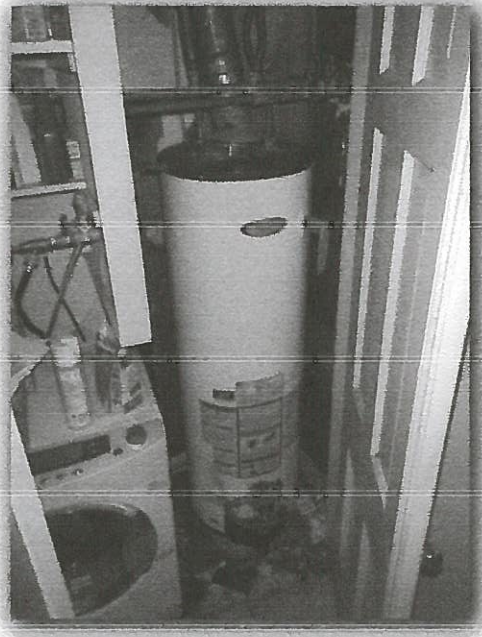
Comments: 2007 model Tank

- **If Remodeling**, Junk the Heater and install a new Tankless Heater at the exterior wall.

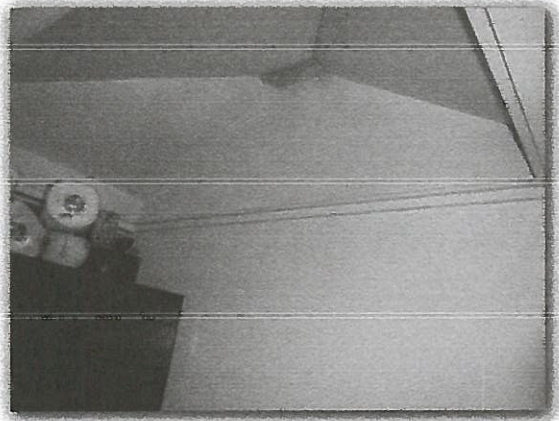
- **Vent Hood lacks an Exhaust Fan.** Replace this Hood during Remodeling.

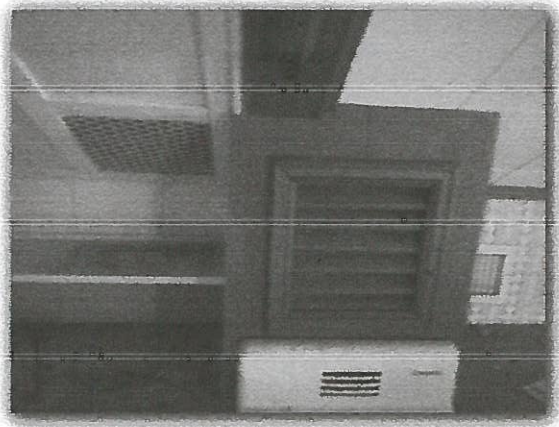
- **Kitchenette has an Exhaust Vent** above the Range blowing to the Attic behind it!

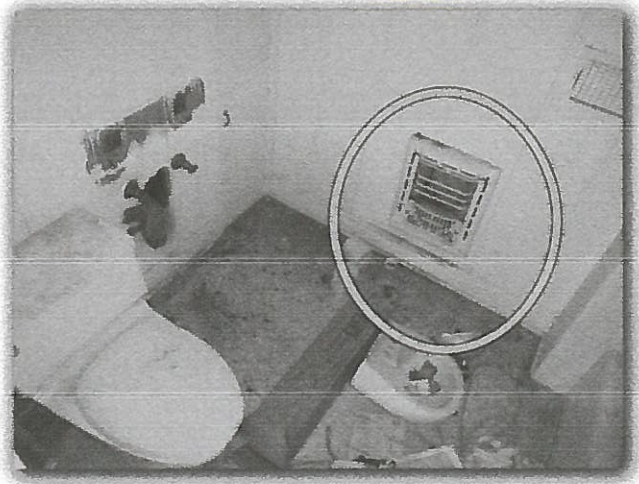
- **Non-Vented Gas Wall Heaters** in Bathrooms to be removed if Remodeling.

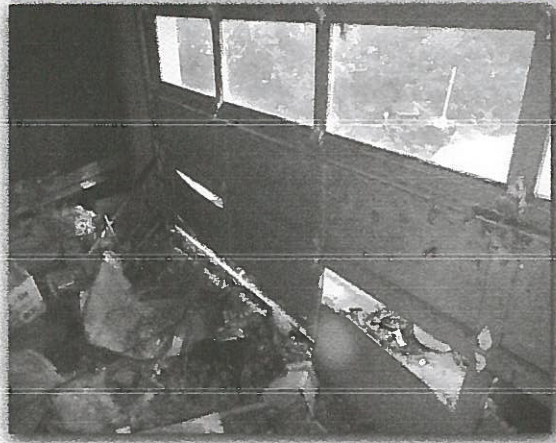
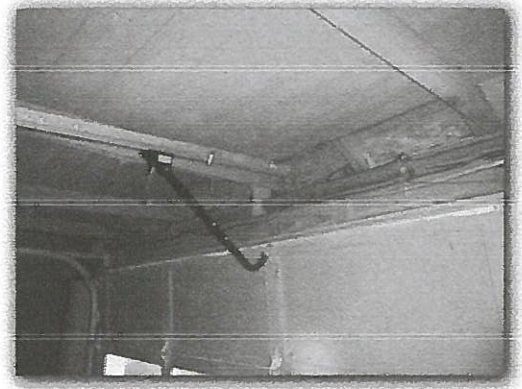
- See 'Exterior Walls'.
- Overhead Garage Door beyond repair.

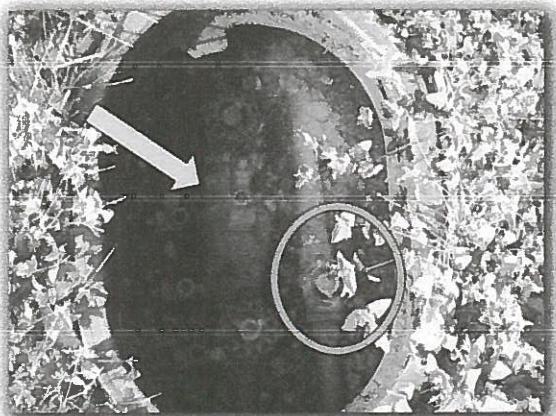
- **Backflow Preventer Valve** in Box next to Water Meter (arrow in photo is old and partially submerged in soil Valve will need to be replaced, or rebuilt.

Note: Owners Water Supply Valve (ringed in same photo) is next to it.
